### Site 102 Labor In Vain Creek

Great Marsh Coastal Wetlands Restoration Plan  
Rapid Technical Assessment Site 102

# Great Marsh Coastal Wetlands Restoration Planning

## Rapid Field Assessment

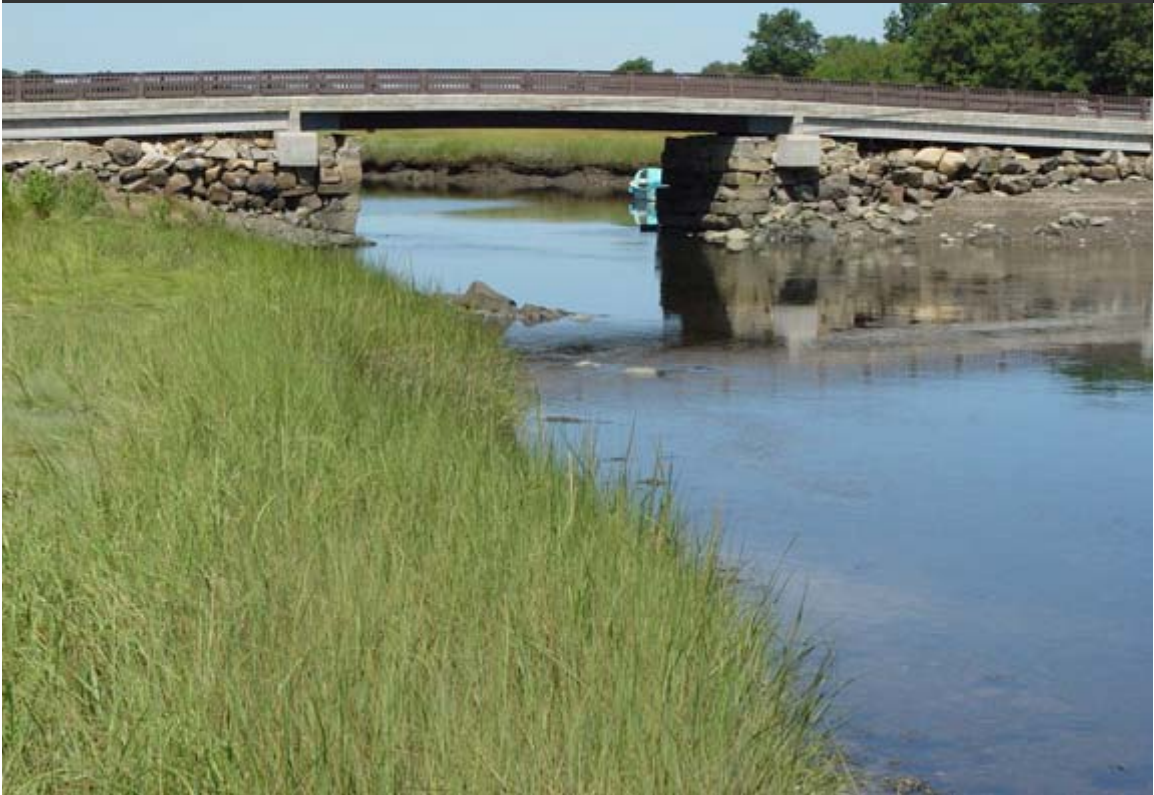
**Photo 1 - Healthy High Marsh Downstream of Restoration Area**

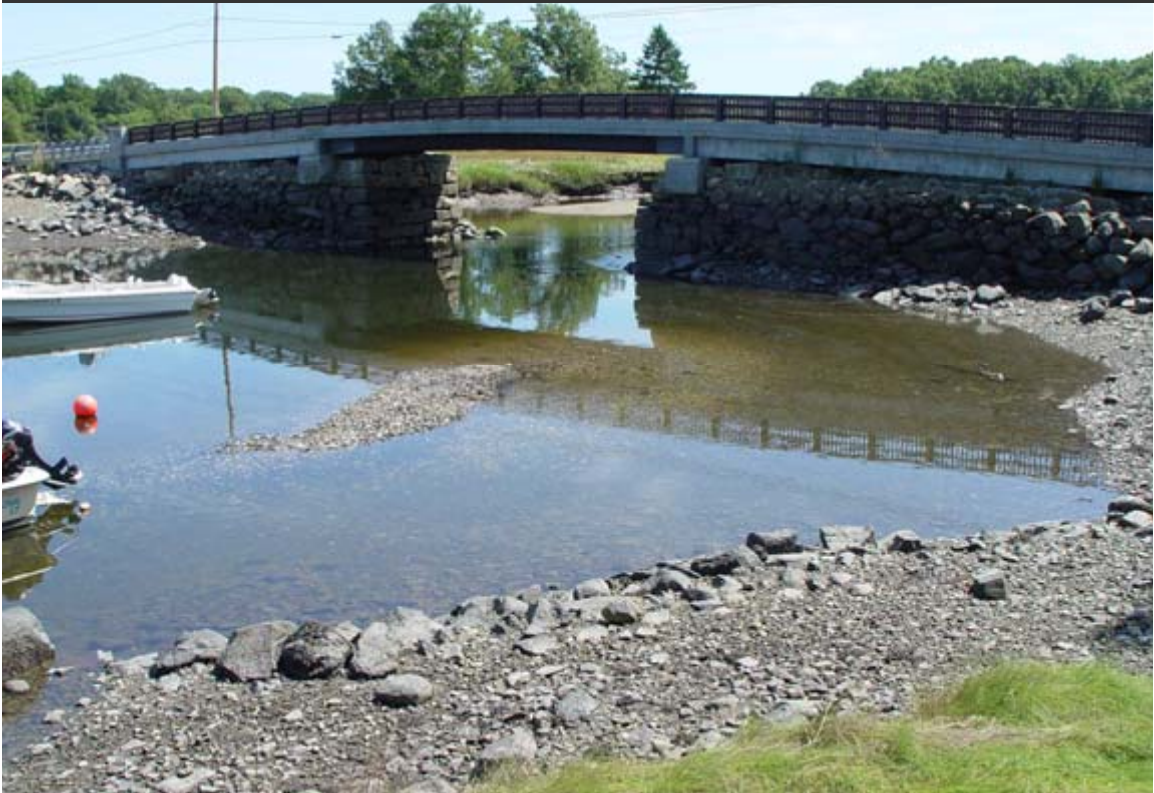
**Structure conditions:** The Labor in Vain Creek Bridge was constructed in 1996. Labor in Vain Road was resurfaced in the vicinity of the crossing and is generally in good condition. However, over wash during spring storms caused some erosion of the roadbed on the south side of the road, east of the crossing. Bridge plans on file with MassHighway District 4 were reviewed. The bridge structure consists of three spans with a combined length of 156 ft. The main (center) span is approximately 60 ft in length and is a cast-in-place concrete deck on steel beams. The two outer spans are approximately 48 ft in length and are cast-in-place concrete decks on concrete boxbeams. The main span and outer spans are supported by pier caps on top of concrete piles driven to bedrock. Cut stone and rubble is located under the outer spans and a cut stone façade was constructed around the two piers in the creek. The effective opening between the two piers is approximately 45 feet. The width of the structure is approximately 28 ft consisting of two travel lanes and narrow shoulders. The span includes three-beam bridge rail. Overall, the bridge deck, beams, and piers are in good condition.

**Photo 2 - Downstream View of Bridge Crossing**

The overall severity of the existing impairments is considered moderate. Increasing the effective opening under the bridge by removing fill between the center piers and abutments would likely reduce the observed bank erosion near the crossing and help to alleviate the restriction in flow experienced during spring tide conditions. Further study is necessary to assess the benefits of replacing secondary culverts within the system. Expansion of fringing populations of *Phragmites* and other brackish marsh vegetation would be expected without measures to address the tidal restriction.

***Construction Logistics/Feasibility:*** The overall constructability for this site is medium. Increasing the hydraulic capacity through the bridge structure would involve removing most of the cut stone and fill between the bridge abutments and piers. With adequate scour protection to both the central piers and abutments, a portion the stone between can be removed without adversely impacting the structural integrity of the bridge. The removal of fill under the outer spans will be selective excavation which, in general, is a costly operation. The work would involve the placement of construction equipment within the creek channel and therefore require large cofferdam structures. There is likely value to the stone which would be removed avoiding deposal costs of the material. There is limited room near the bridge for construction staging; however the project should only require a small staging area. One-way traffic can be maintained during construction. There are no known underground utilities. Overhead electrical lines would likely interfere with the installation of cofferdam sheet piles. Construction costs are estimated to be in the range of \$300,000. Much of the construction cost is related to the installation of coffer dams along both approaches to facilitate work in the dry. Local support for this restoration effort is unknown.

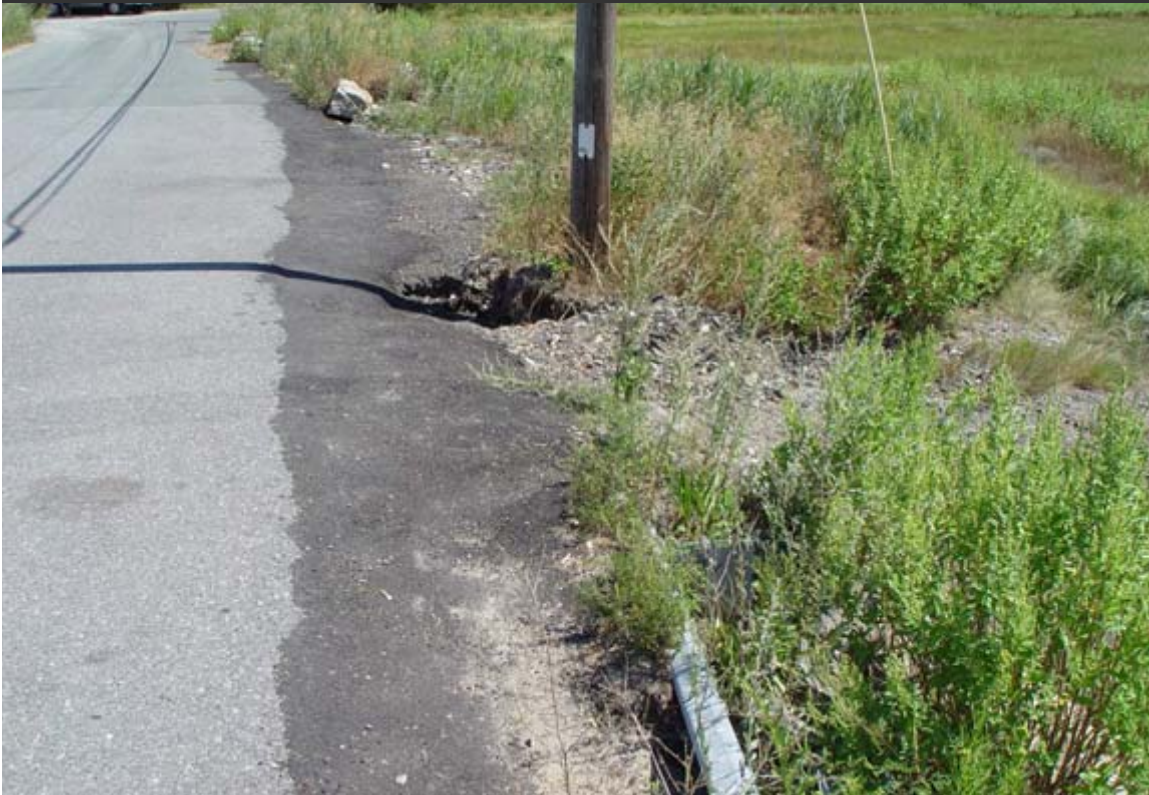
**Photo 3 - Road Damage East of Bridge Approach**

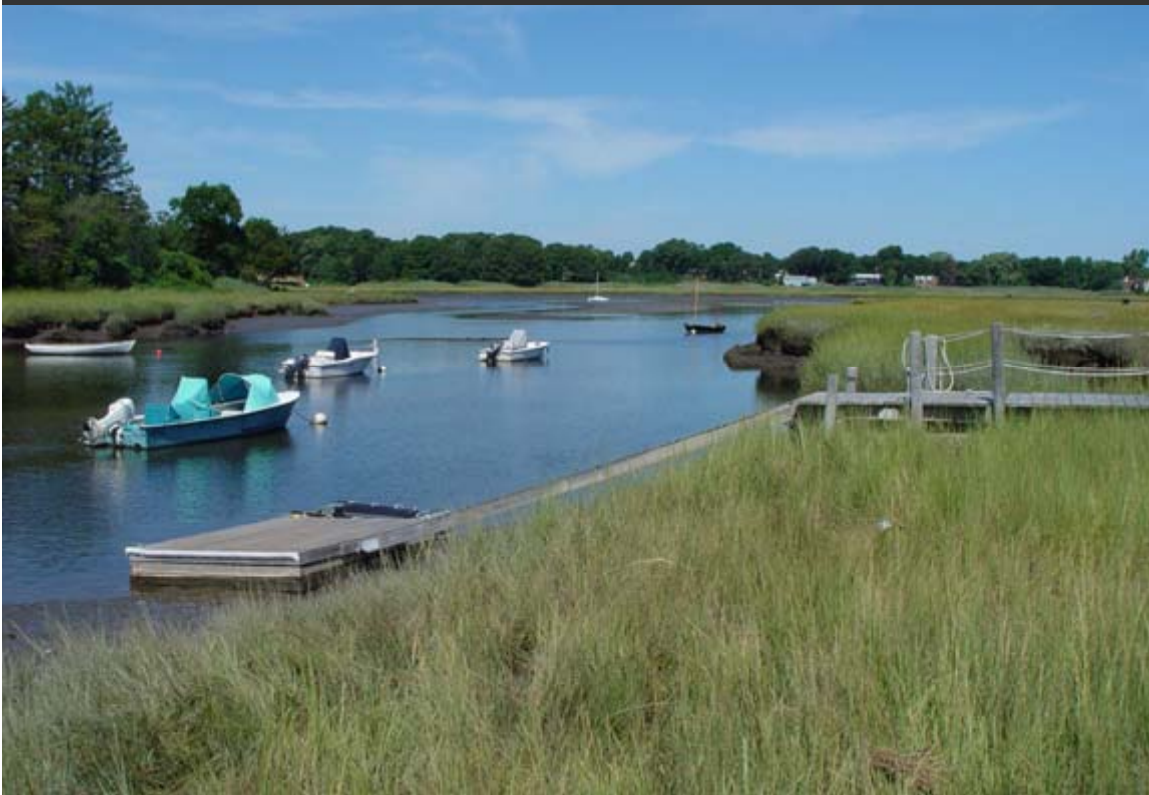
**Photo 4 - Marsh Downstream of Crossing**

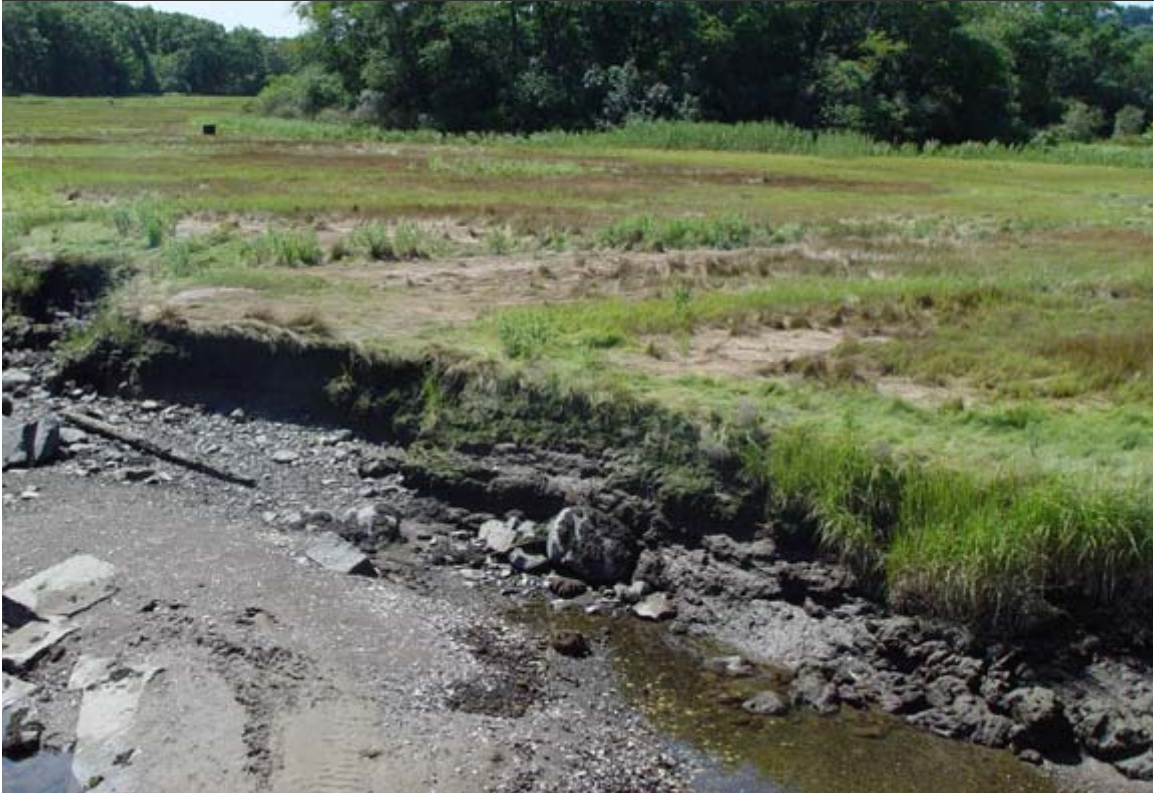
**Photo 5 - Marsh Downstream of Crossing**

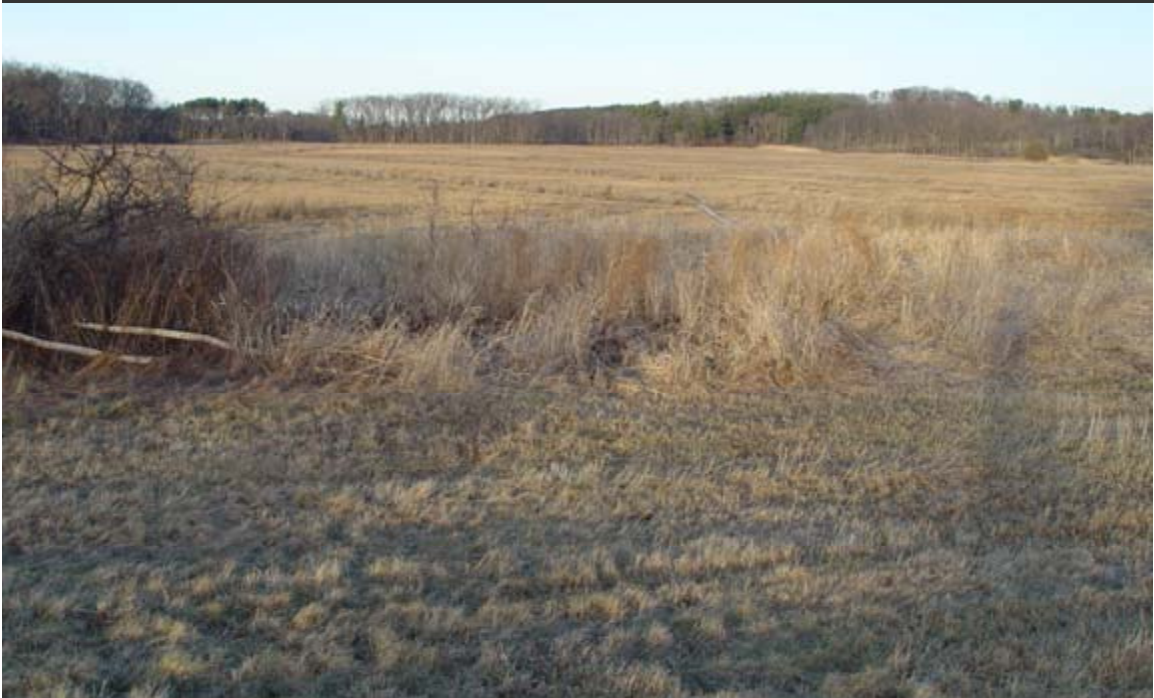
**Photo 6 - Southern Portion of Site Viewing North**

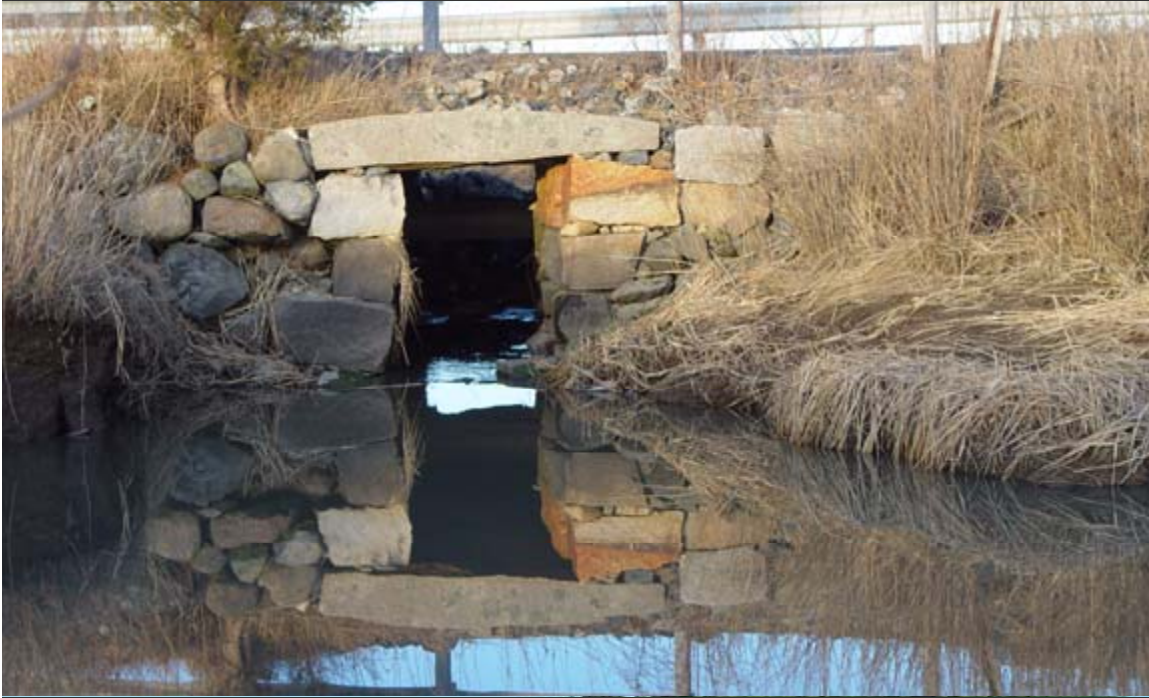
**Photo 7 - Upstream View of Stone Box Culvert Under Argilla Road**

restriction may exist at this location. This work could improve tidal exchange within the southern limits of the marsh but not increase flow within the greater marsh. Improvements at the culvert conveying Treadwell Island Creek under Fox Creek Road appears to offer the best potential among the three smaller culvert crossings. The primary direction of flow under the culvert closest to the Labor in Vain bridge is to the north during an incoming tide. The middle crossing is located at the upper reaches of a small creek extending from the Ipswich River. The creek does not continue south of Fox Run Road. Providing a better hydraulic connection to existing ditching south of the road may result in modest benefits within this portion of the marsh.

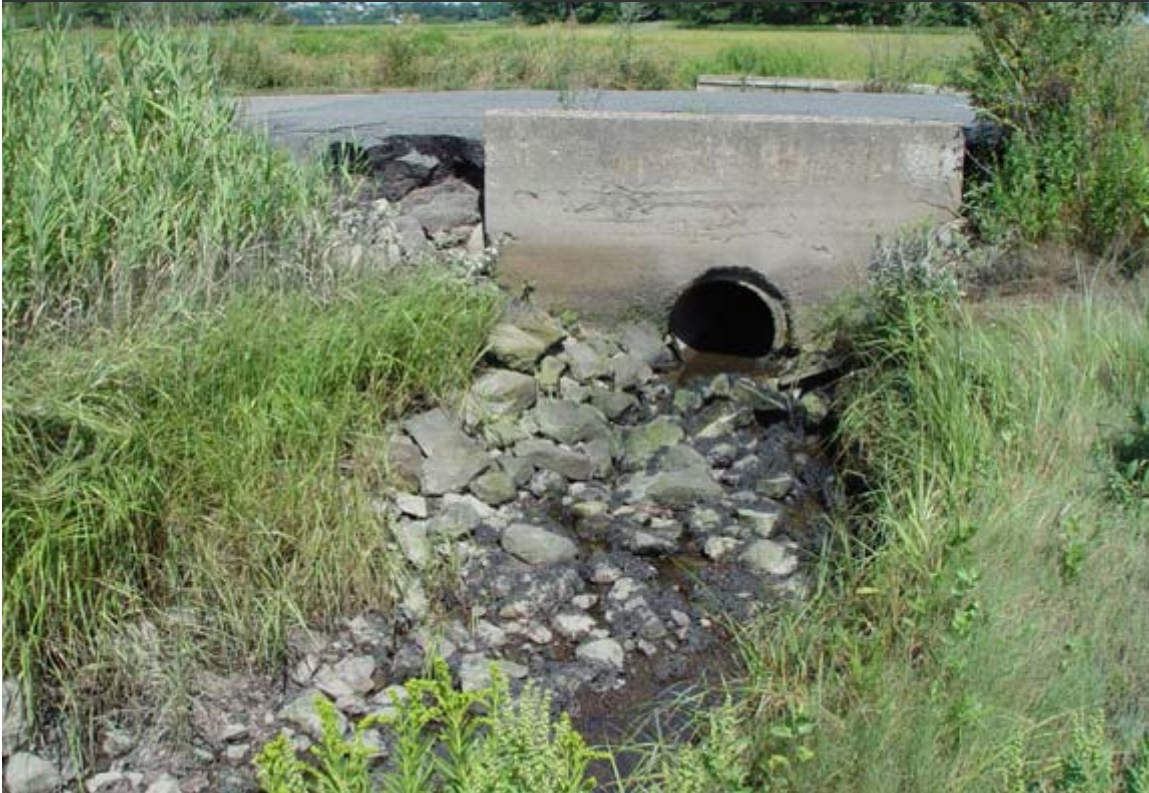
**Photo 8 - Upstream View of Western Fox Creek Road Crossing**

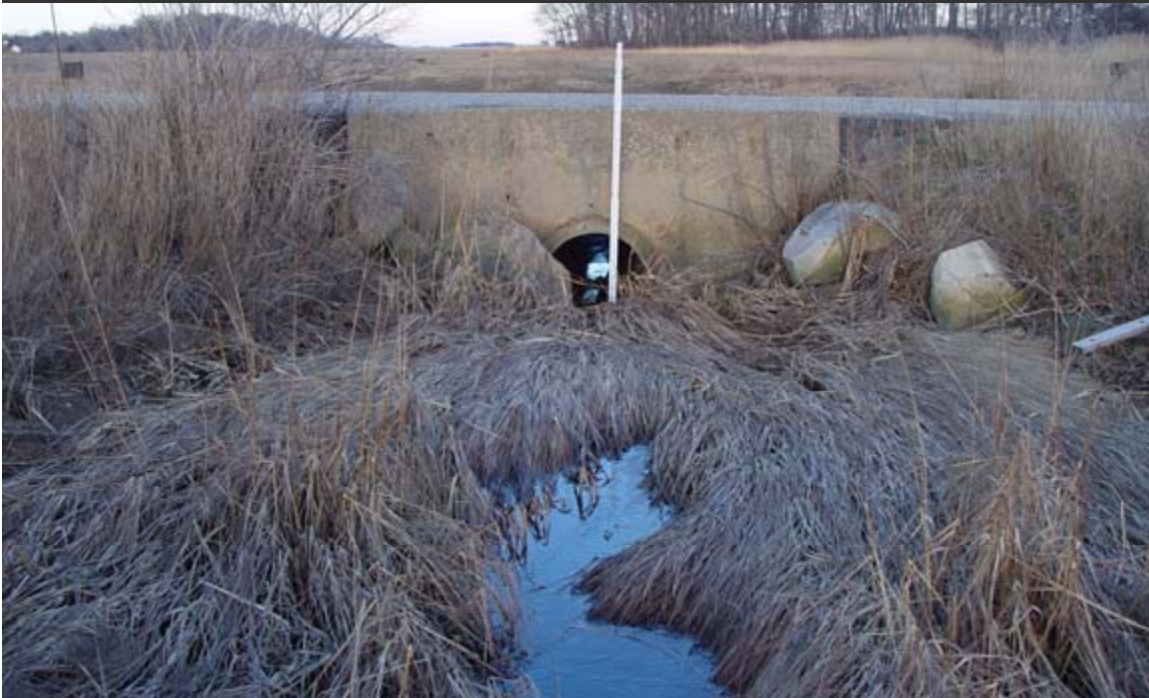
**Photo 9 - Upstream View of Middle Fox Creek Road Crossing**

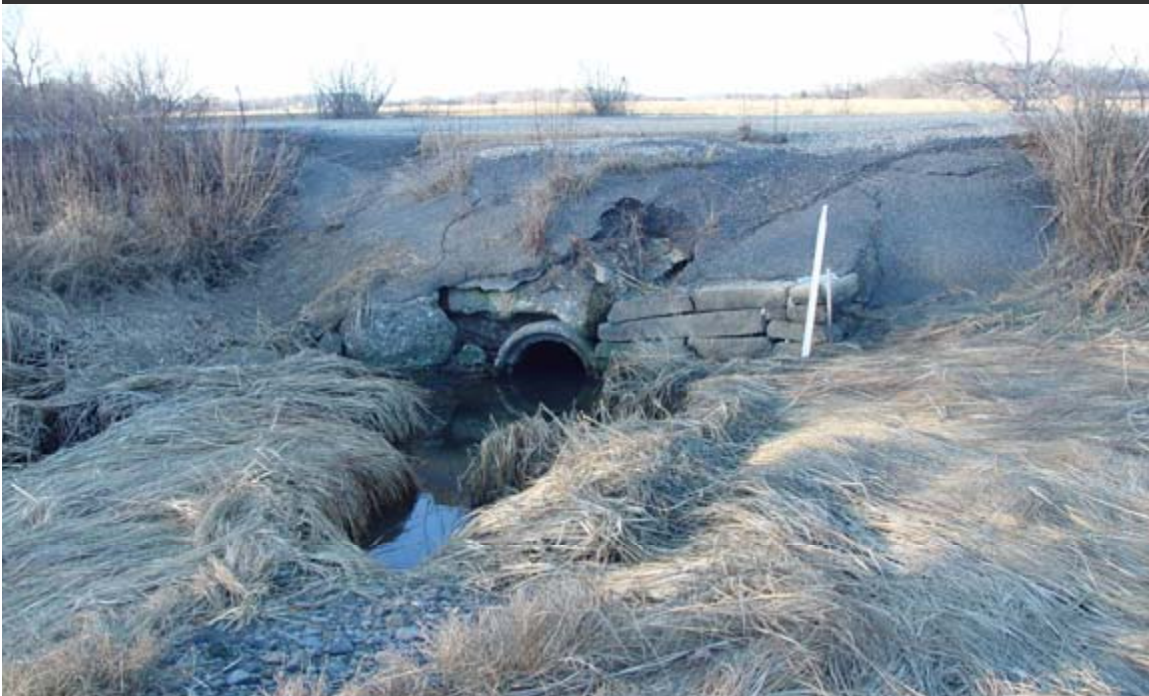
**Photo 10 - Upstream View of Eastern Fox Creek Road Crossing**

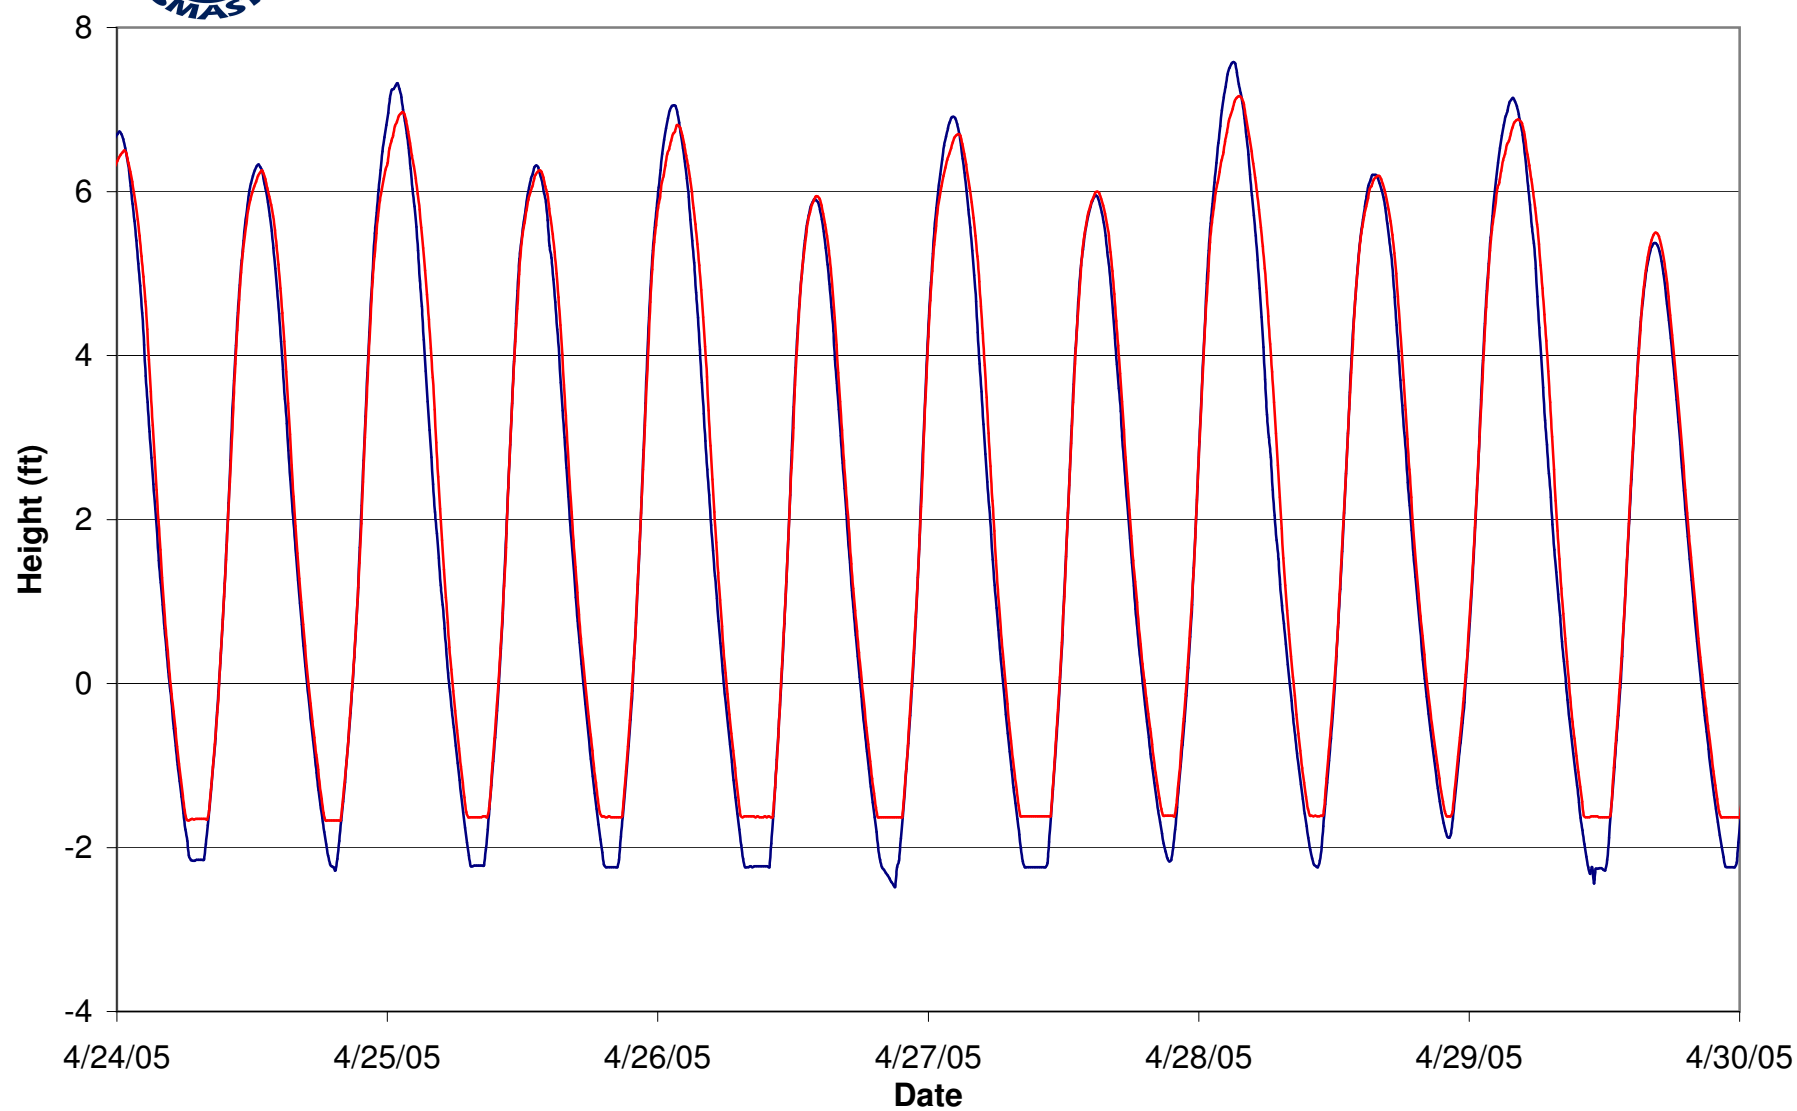
## Site 102: Labor In Vain Creek, Ipswich, MA

There were two deployments of tide gauges to Labor in Vain Creek: one from April 19 to May 2 and the other from August 11 to September 9, 2005. At each deployment, two tide gauges were installed: one upstream and one downstream of the Labor in Vain Road bridge. Results of the April/May deployment show a small restriction at the bridge which becomes more pronounced at the higher tides above 6 ft, which occurred on 10 of the 25 tidal cycles recorded. Tidal restrictions ranged from less than 0.1 ft to 0.42 ft and delays ranged from less than 10 minutes to 27 minutes. The highest tide during the deployment period was recorded on April 28 at 3:04 AM. The NVGD adjusted height downstream of the bridge was 7.58 ft. The upstream adjusted height was 7.16 ft and occurred at 3:31 AM. The restriction caused a tidal dampening of 0.42 ft upstream of the bridge and a delay of 27 minutes. The dampening amounted to approximately 4.3% of the total tidal prism recorded at the downstream gauge.

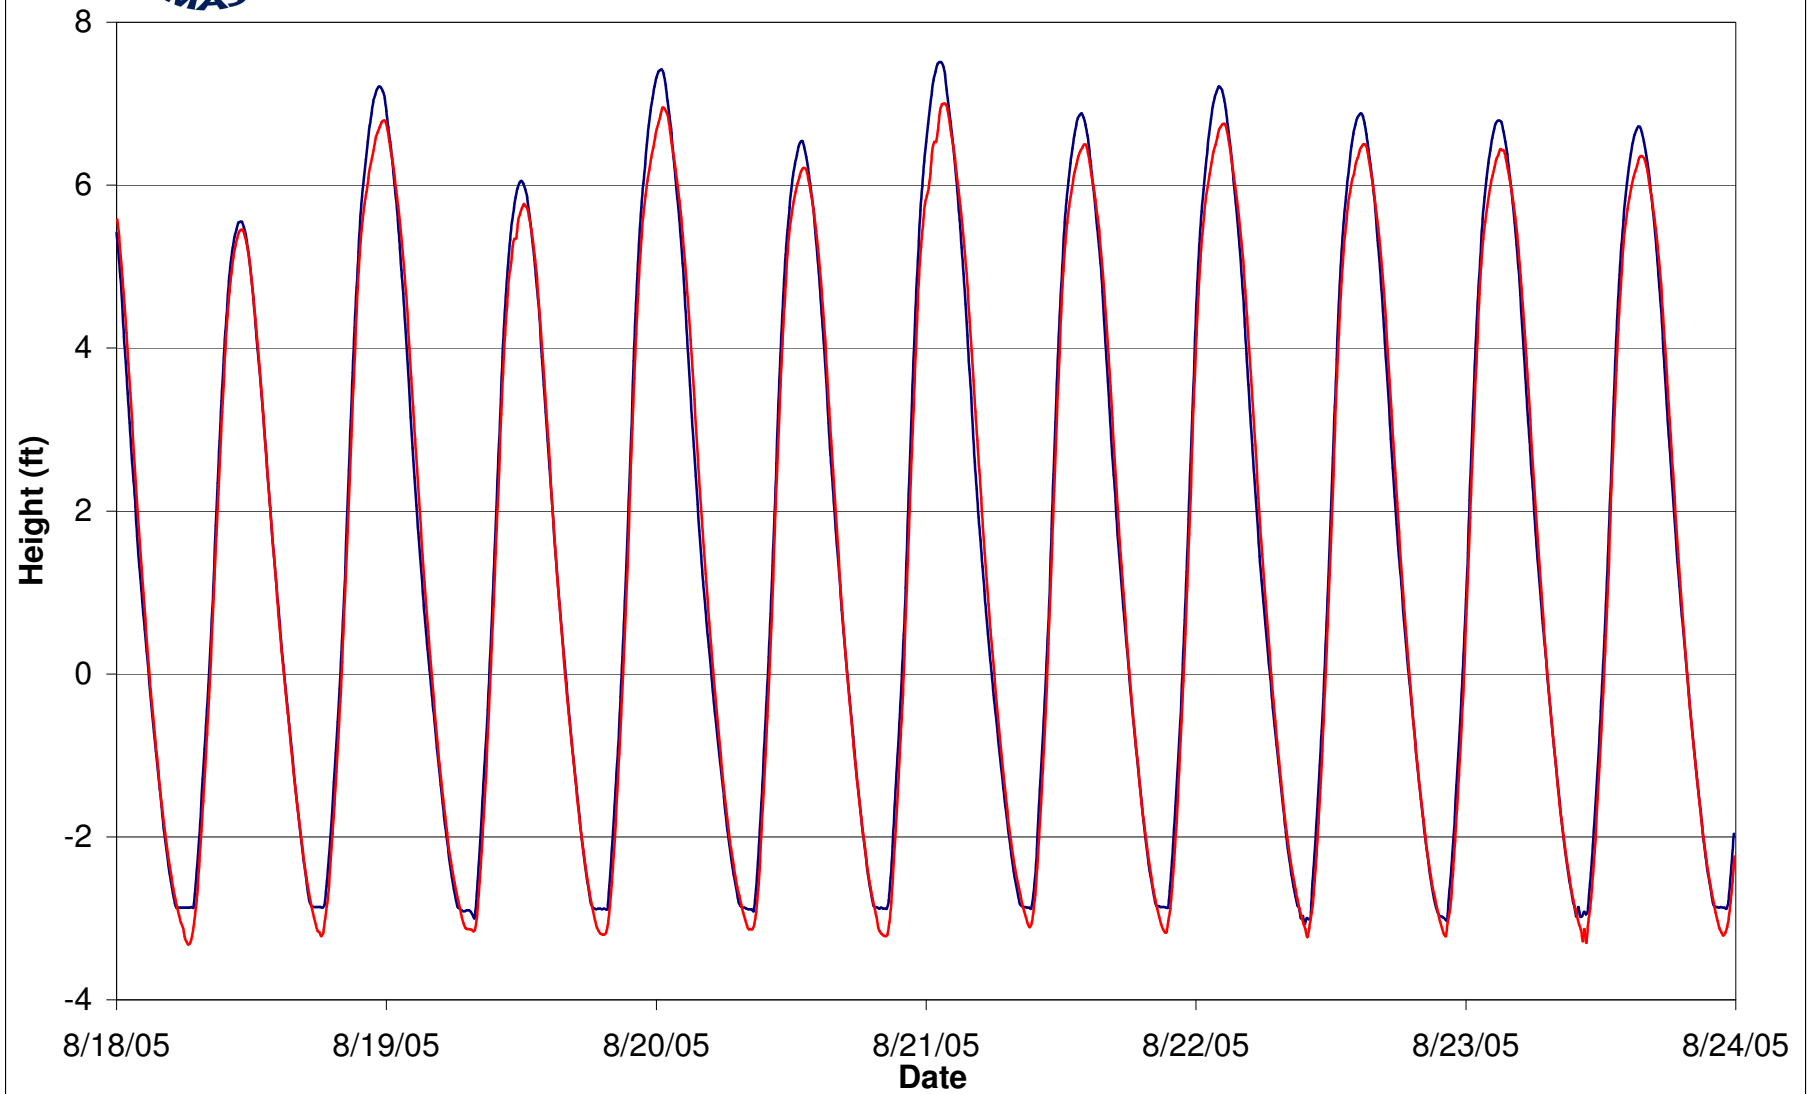
## Site 102: Labor In Vain Creek, Ipswich, MA

Results of the August/September deployment show a similar restriction at the bridge which becomes more pronounced at the higher tides above 6 ft., which occurred on 13 of the 52 tidal cycles recorded. Tidal restrictions varied from 0.1 to 0.51 ft. and delays ranged from less than 10 minutes to 23 minutes. The highest tide during the deployment period was on August 21 at 1:10 AM. The NVGD adjusted height of the water downstream of the bridge was 7.51 ft. The upstream adjusted height was 7 ft which occurred at 1:33 AM. The restriction caused a tidal dampening of 0.51 ft upstream of the bridge and a delay of 23 minutes. The dampening amounted to approximately 4.9% of the total tidal prism recorded at the downstream gauge.
